Subject: Department of Natural Resources Washington Geological Survey,
School Seismic Safety Assessment Project, Contract No. AE 410 -
Seismic Evaluation for **Evaline School District**

1. Evaline Elementary School, Main Building

1.1 Building Description

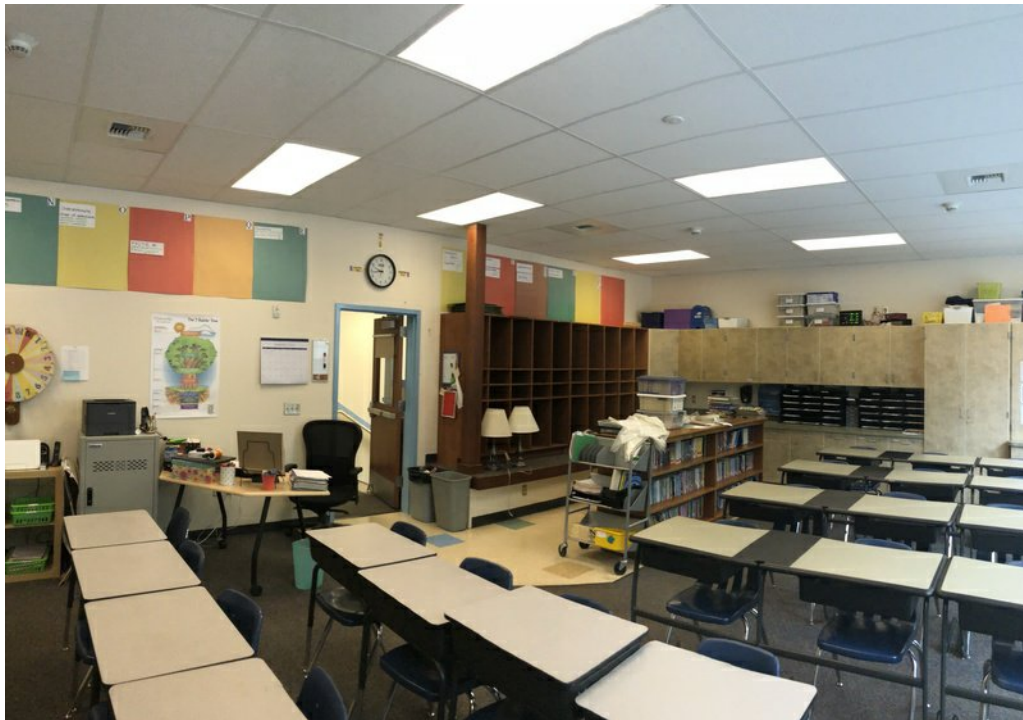
Unknown Item	Description
LF-1 Independent Support. HR-not required; LS-MH; PR-MH.	Further investigation is required to review the support system for light fixtures. All light fixtures in grid ceiling system should have seismic bracing.
CG-8 Overhead Glazing. HR-not required; LS-MH; PR-MH.	Further investigation is required to verify detailing of glazing panes.
S-1 Stair Enclosures. HR-not required; LS-LMH; PR-LMH.	Unknown if restrained out-of-plane. Further investigation is required to verify stair wall out-of-plane anchorage.
S-2 Stair Details. HR-not required; LS-LMH; PR-LMH.	No drawings available. Further investigation is required to verify stair connections.

Figure 1-1. Typical Classroom with Unknown Light Fixture Bracing

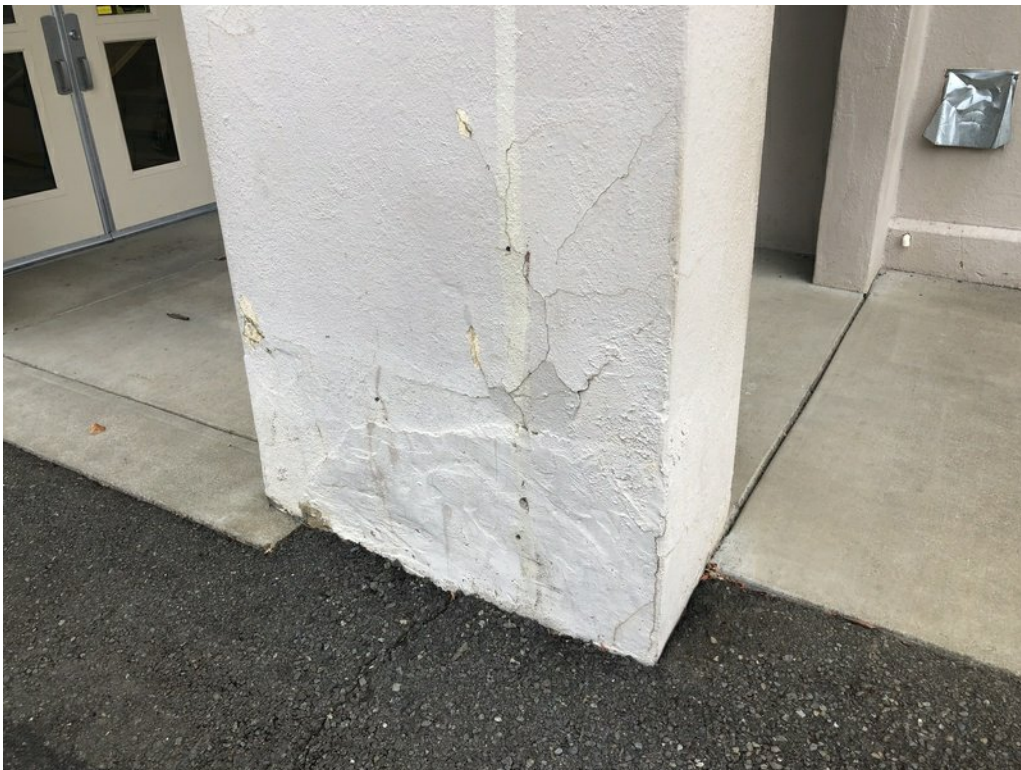
Structural System	Description
Structural Roof	No visible signs of corrosion, damage, or deterioration.
Structural Floor(s)	No visible signs of corrosion, damage, or deterioration.
Foundations	Unknown.
Gravity System	Exterior finishes show cracking.
Lateral System	Exterior finishes show cracking.

Figure 1-4. Cracking in Exterior Finish at Column

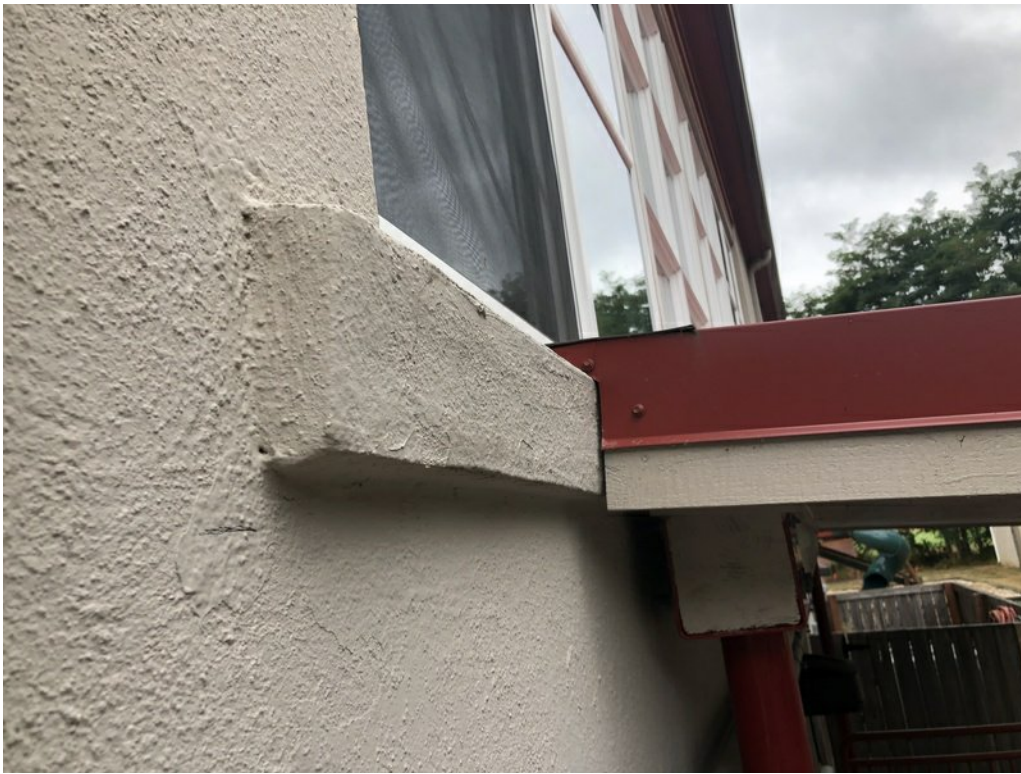
Deficiency	Description
PCOA-2 Canopies. HR-not required; LS-LMH; PR-LMH.	Inadequate anchorage of canopies at building exits to the main structure. Additional post-installed anchors may be appropriate to ensure six feet maximum anchor spacing.
CF-2 Tall Narrow Contents. HR-not required; LS-H; PR-MH.	Anchorage is required for tall narrow contents more than six feet high to provide overturning restraint.
ME-3 Tall Narrow Equipment. HR-not required; LS-H; PR-MH.	Anchorage is required for tall narrow equipment more than six feet high to provide overturning restraint.

Figure 1-5. Canopy Connection to Structure Likely Requires Additional Anchorage

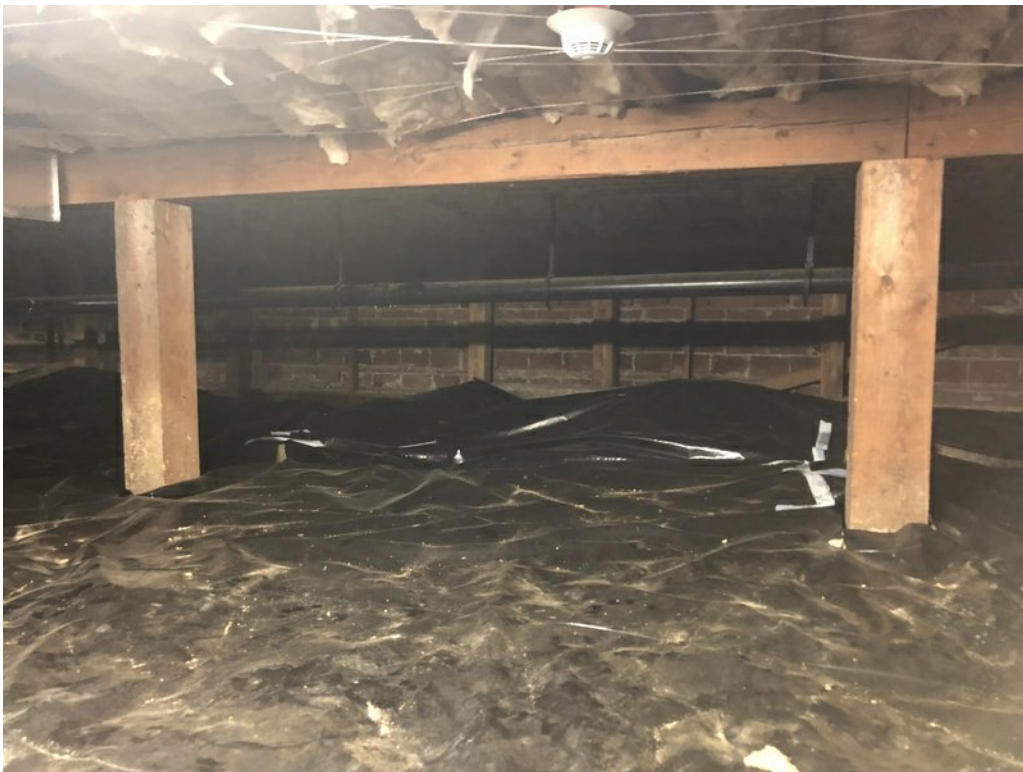
Wood Ledgers	This evaluation item is likely non-compliant due to the building's age, but could not be visually verified. This item requires further field investigation to make a final determination and to develop a mitigation recommendation, if necessary.
Transfer to Shear Walls	This evaluation item is likely non-compliant due to the building's age, but could not be visually verified. This item requires further field investigation to make a final determination. Post-installed anchors may be required to connect the diaphragm to the URM shear walls.
Girder-Column Connection	No positive connection between girders and column supports was observed in the crawlspace. It could not be visually verified if positive connections are also non-existent throughout the rest of the building. Further investigation is required to determine the extent of non-compliance. Positive connections should be provided between all girders and column supports.

Figure 1-8. Crawlspace - No Connection Between Wood Beams and Posts

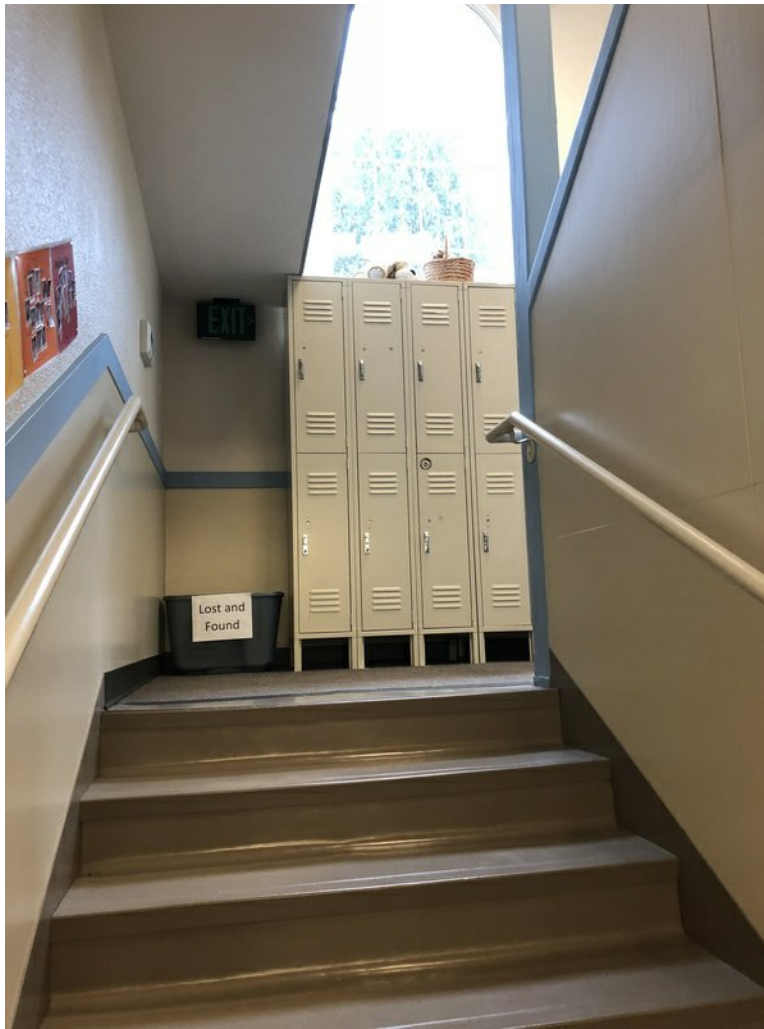
Figure 1-9. Lockers Unbraced in Egress Path

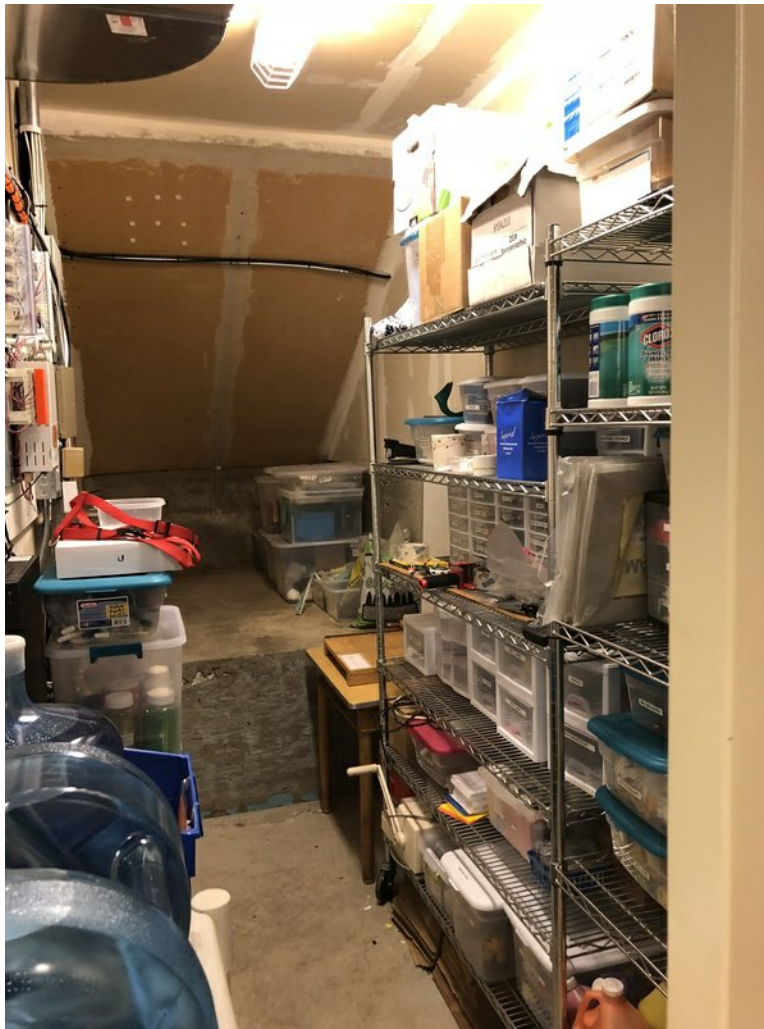
Figure 1-10. Tall Narrow Contents, Typical Throughout
